Technical Report CHL-98-22
July 1998

Three-Dimensional Breakwater Stability Tests at Vale de Cavaleiros, Cape Verde

by Ernest R. Smith, Jeffrey A. Melby

Prepared for Joint Venture RRI-BCEOM

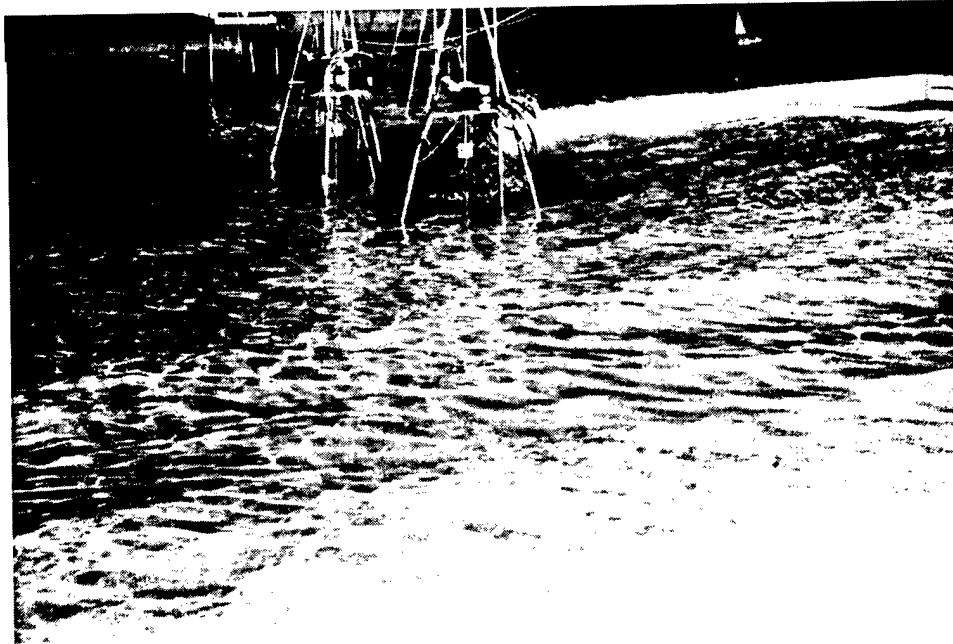
Figure 5. Three-dimensional stability model

Experiments were conducted in a 29.3-m-long, 29.6-m-wide, 1.5-m-deep wave basin. The model was constructed and molded of concrete to represent approximately 825 m of shoreline encompassing the harbor and breakwater location. Contours were molded to -20 m CD, and a 1V on 5H transition slope was molded from the -20-m contour to the model floor elevation of -21.3 m CD. Wave absorber was placed around the perimeter of the basin to minimize the effects of reflection. A photograph of the model is shown in Figure 5.

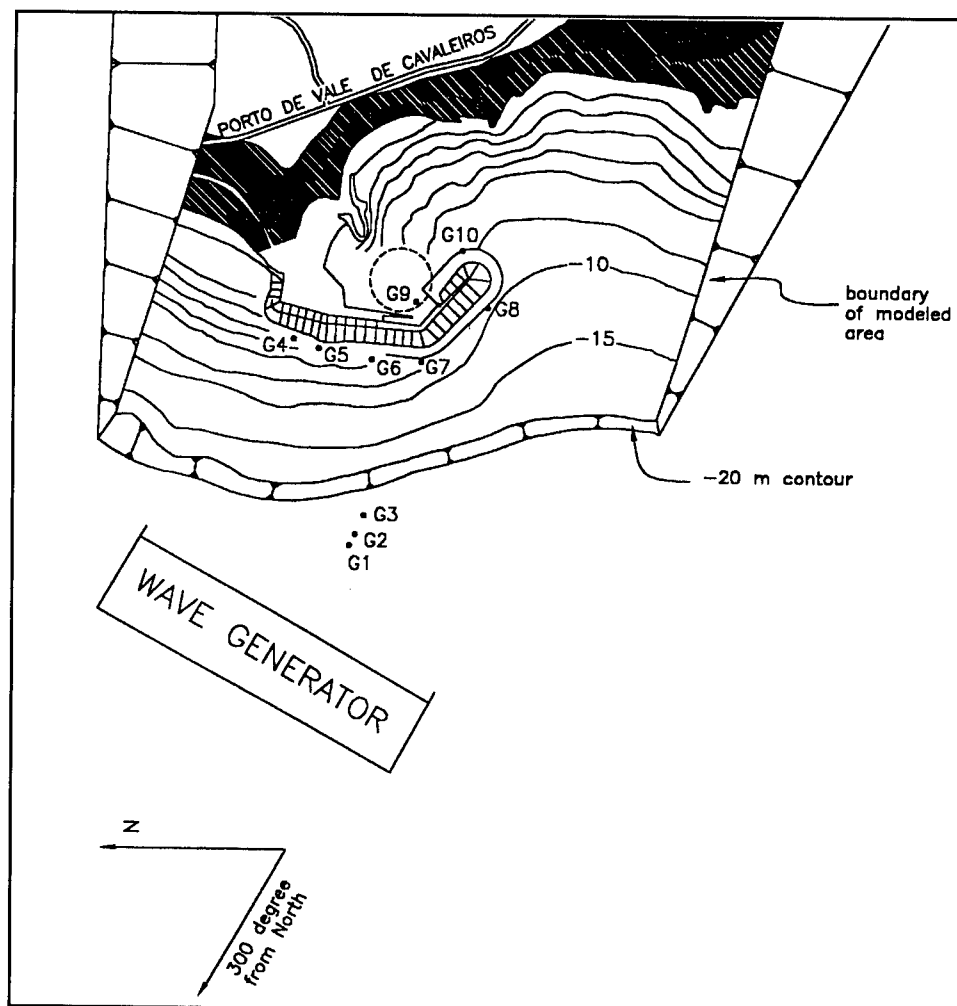
Figure 6. Three-dimensional model boundaries and wave gauge locations

calculation of incident and reflected wave heights by Goda and Suzuki (1976). The remaining gauges were placed at locations around the breakwater shown in Figure 6. Data obtained from the gauges were analyzed using the Time Series Analysis (TSA) computer program of Long and Ward (1987). Operations performed on wave data from individual gauges were mean down-crossing analysis to obtain significant wave height H_s , maximum and average wave heights, significant and average wave periods, and mean water levels at each gauge. Operations performed on the wave gauge array were unidirectional spectral density incident/reflection analysis to determine peak wave period T_p , and incident and reflected wave heights at the gauge array. Following calibration of the basin, Gauges 4 and 5 were removed and used in locations 9 and 10 during stability tests.

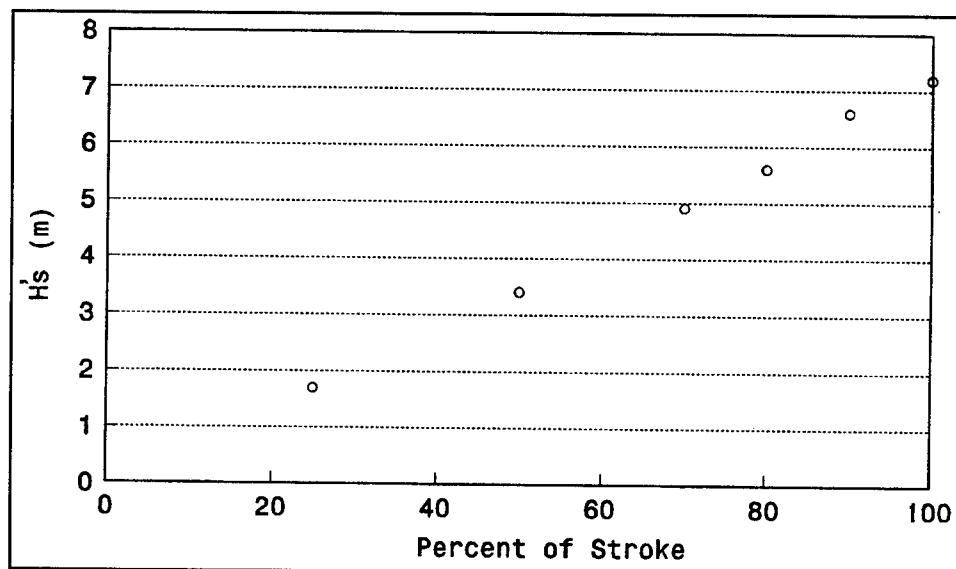
Figure 9. H'_s at -21.3 m CD versus generator stroke, 19-sec waves

Incident significant wave height H_s obtained from Gauges 1 through 3 during calibration is plotted versus percent of generator stroke in Figures 7 through 9.

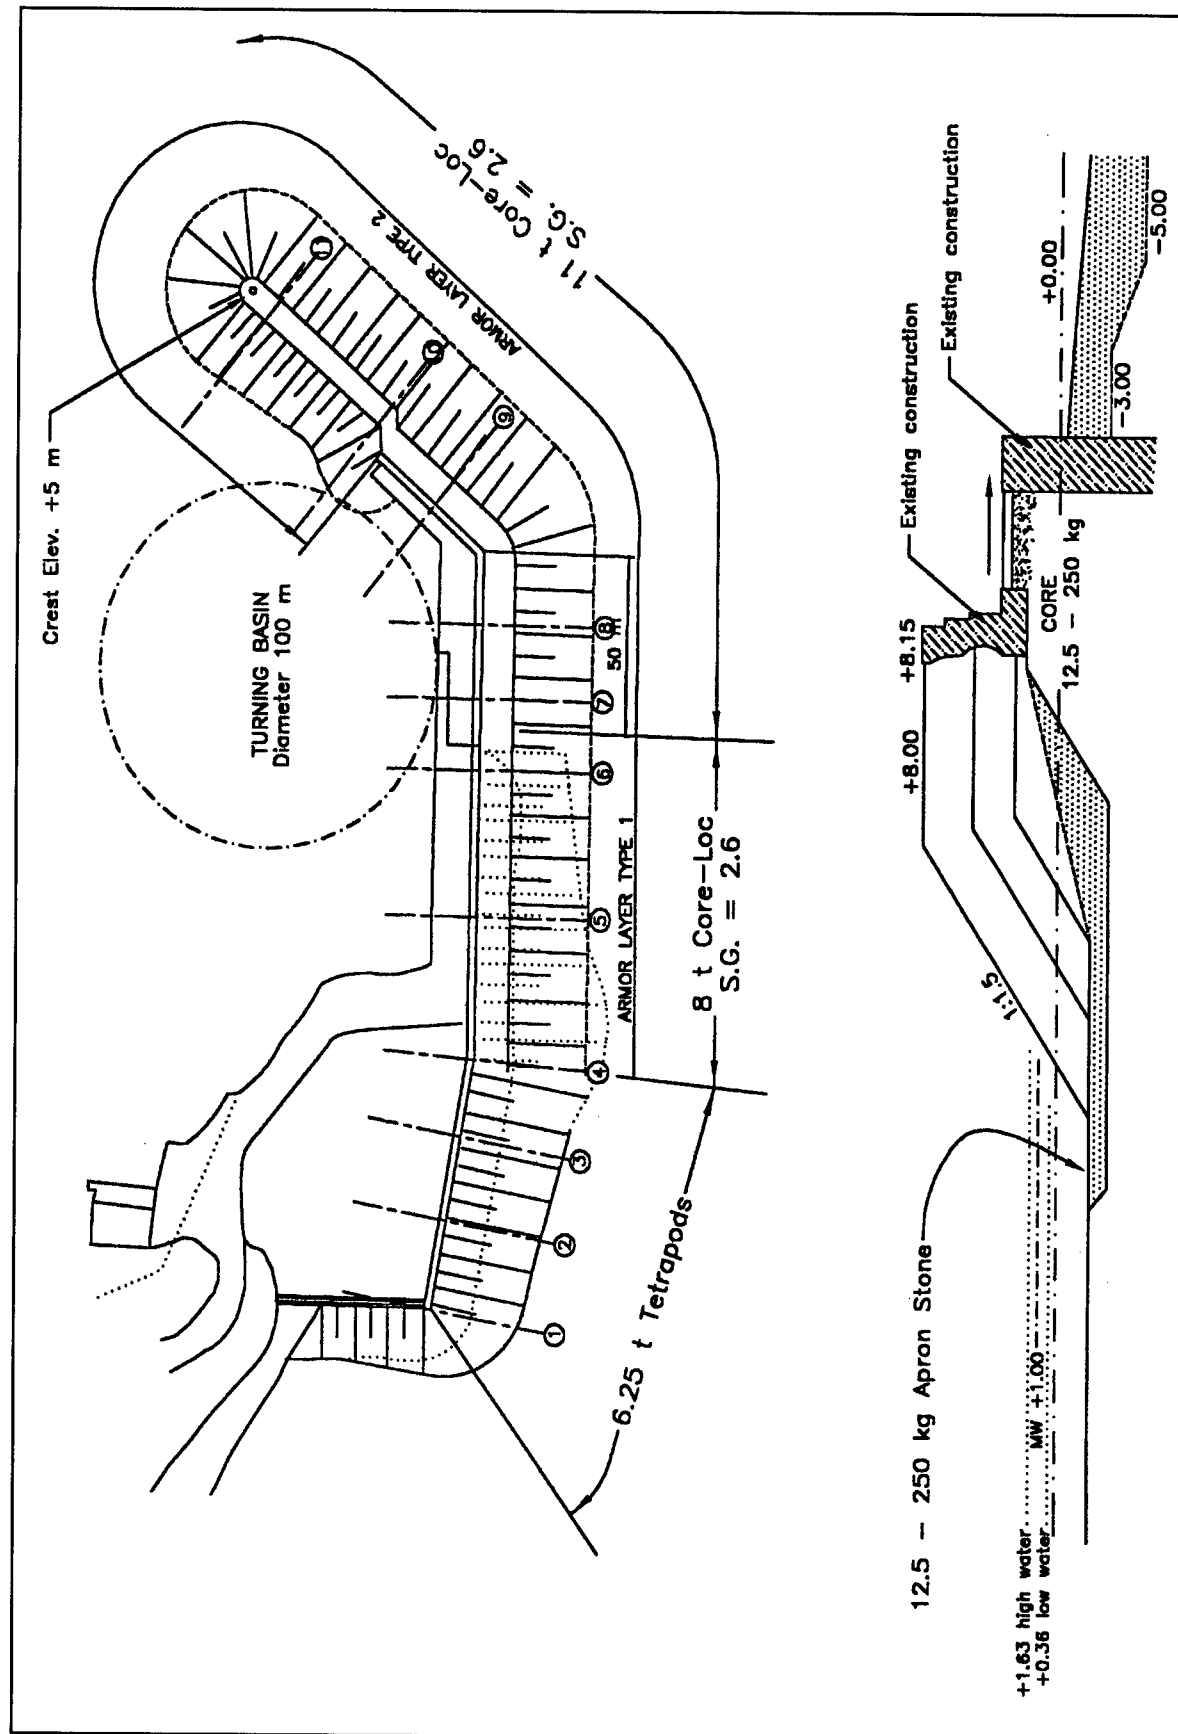
Plan 1, the initial plan (Figure 10, Photos A1 through A3), consisted of 6.25-tonne tetrapods from the shoreward end of the breakwater to Profile 4; 8-tonne Core-Locs from Profile 4 to a point between Profiles 6 and 7 (a total reach of approximately 92 m); and 11-tonne Core-Locs on the remainder of the seaward trunk, around the head and terminating at the quay wall on the leeward side of the structure. For this plan, packing densities of the 8- and 11-tonne Core-Loc reaches were 0.55 and 0.59, respectively. The crest elevation of the head section was +5 m CD. Plan 1 was subjected to “shakedown” waves (13 sec, 3 m) to settle and nestle the armor units. During the wave series, apron material was displaced between Profiles 4 and 9, and Core-Locs were displaced at the toe near Profile 4 (Photos A4 through A6). The structure was subjected to 3.7-m waves for 13- and 16-sec periods, which caused additional toe unit displacement at Profile 4 and at the elbow near Profile 8.

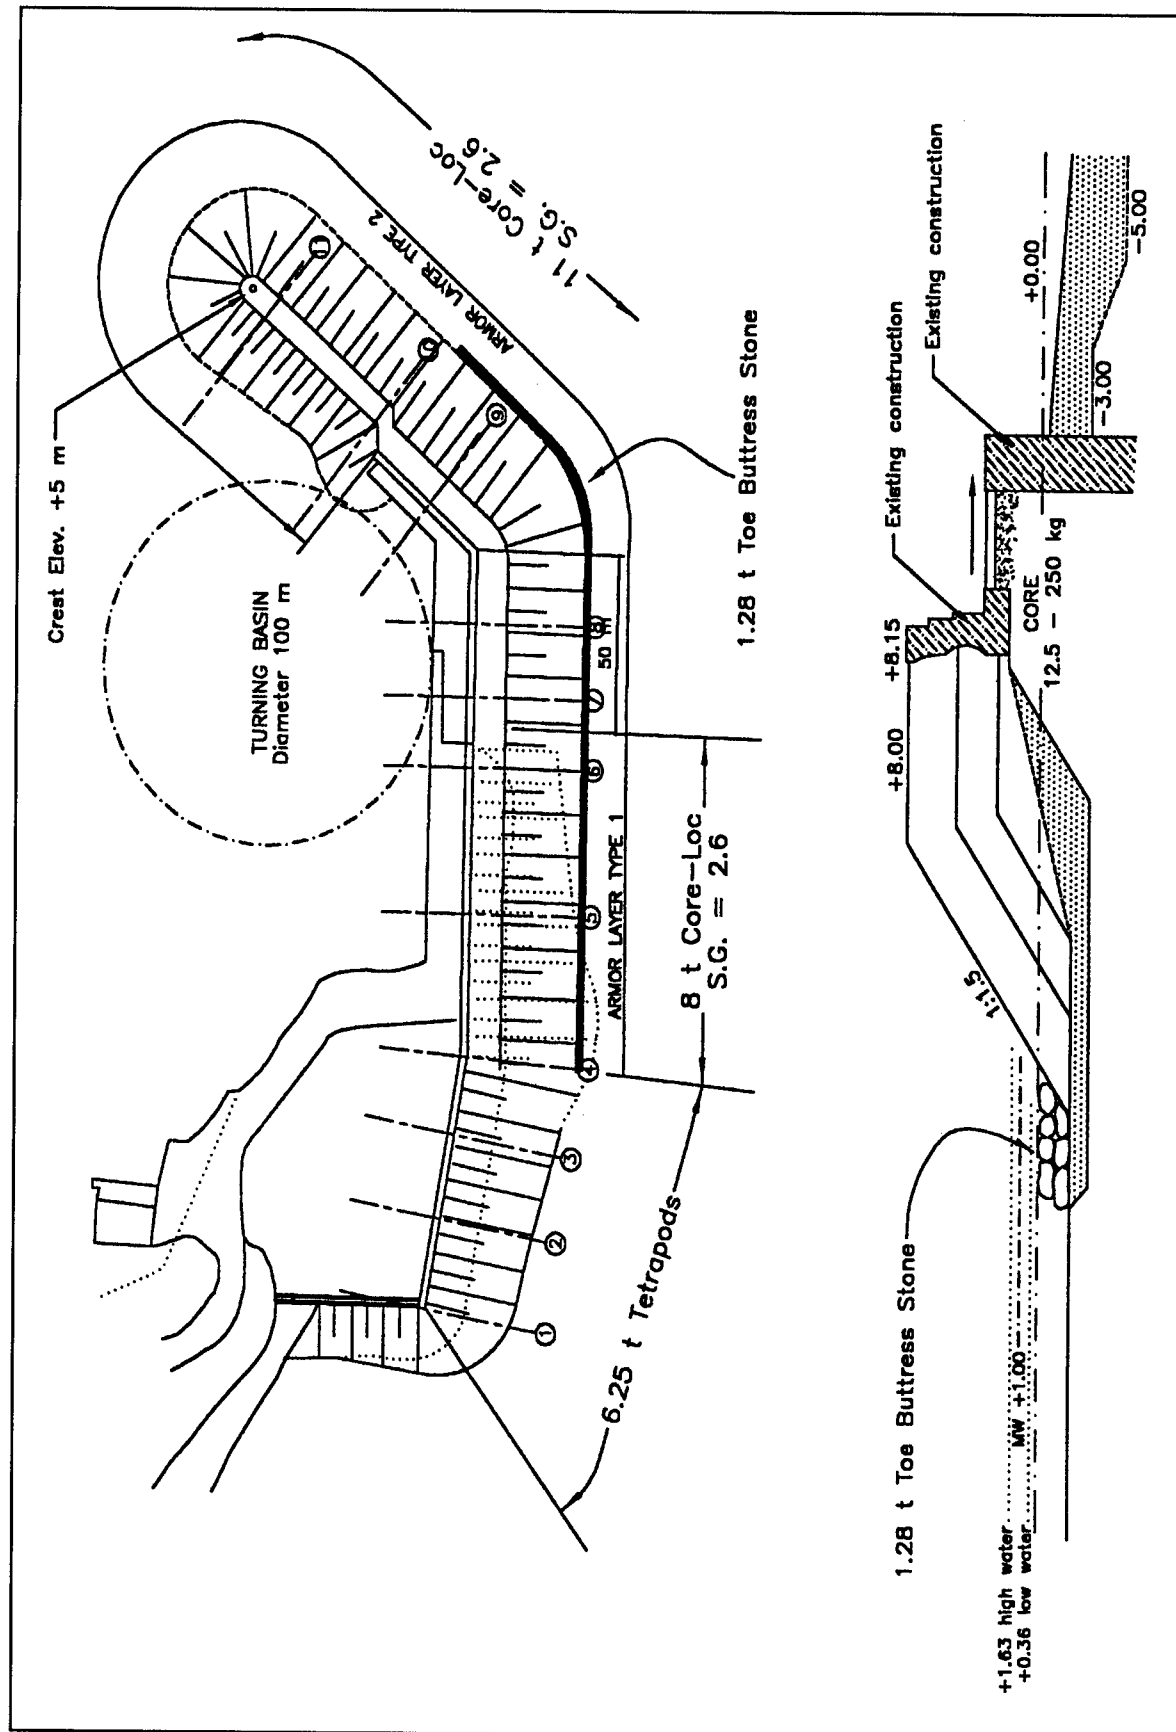
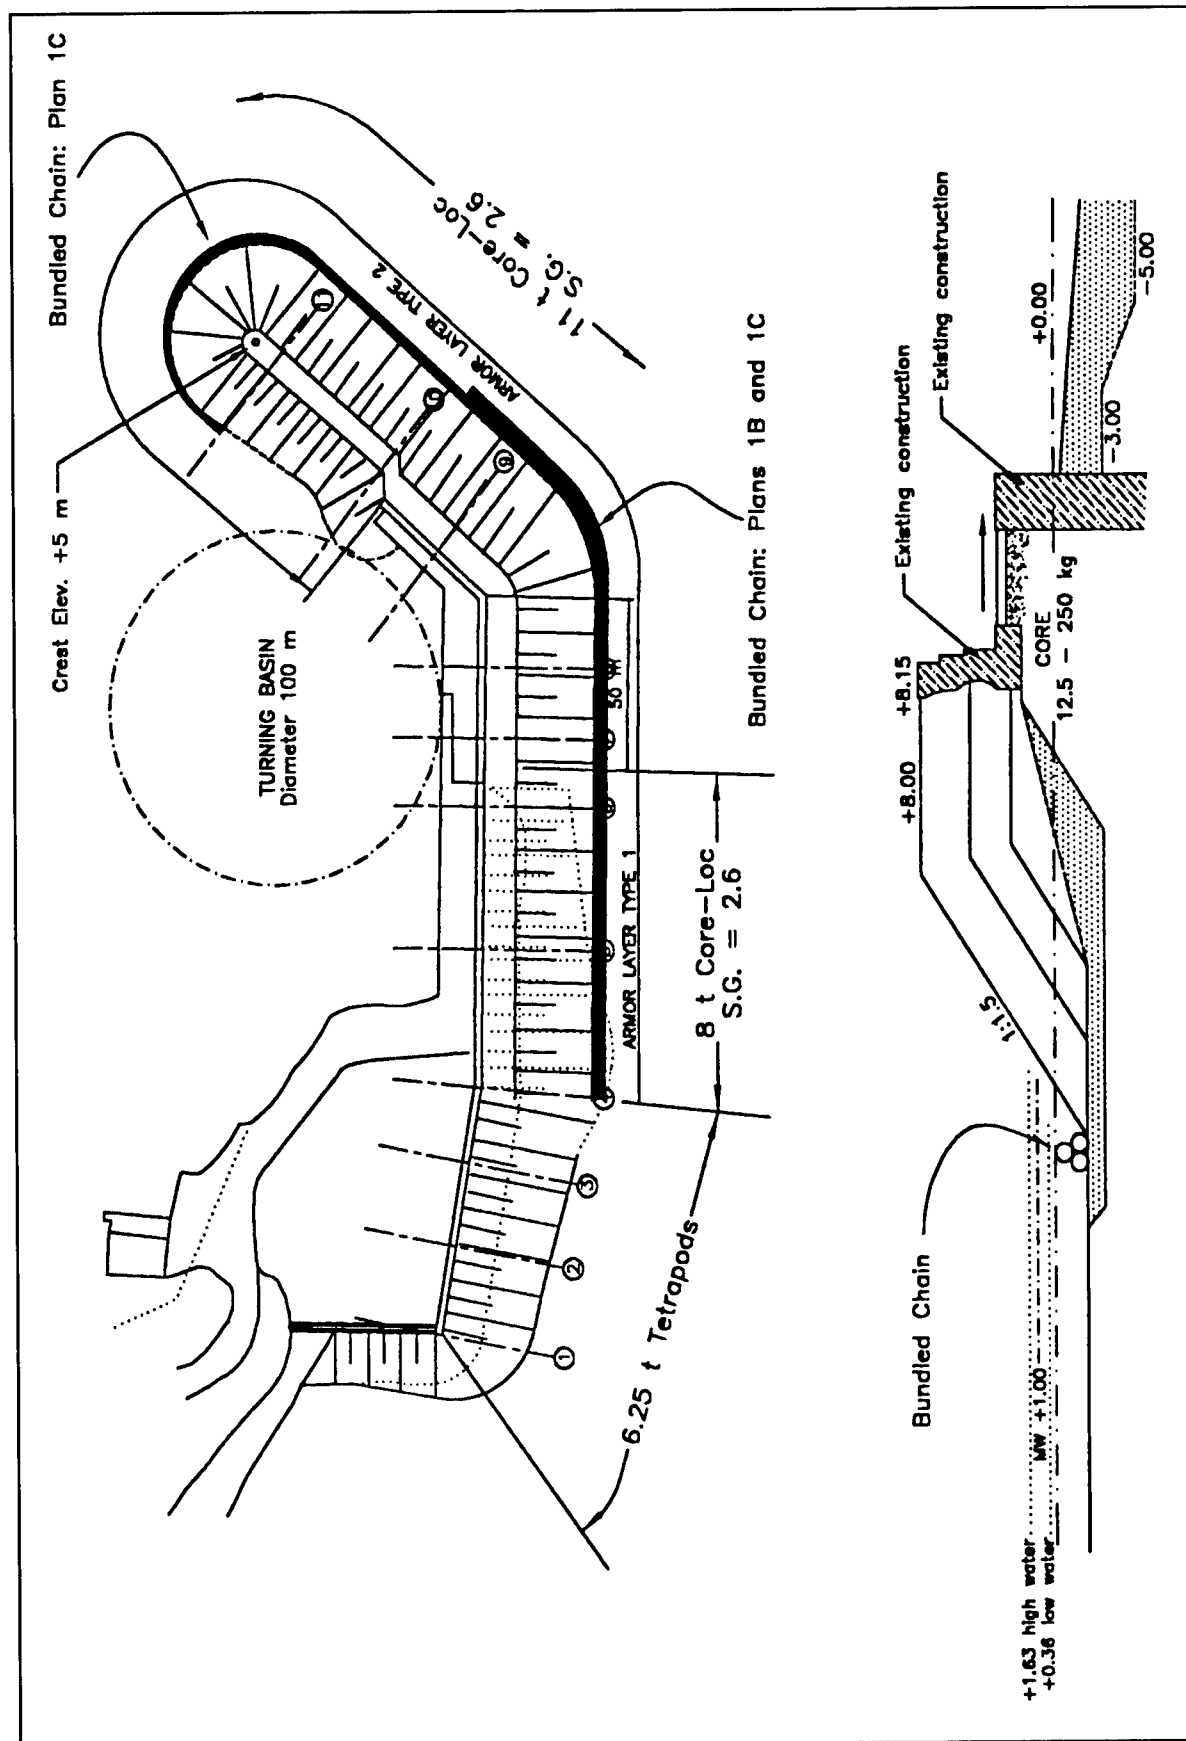
Figure 12. Elements of plans 1B and 1C

Plan 1B was identical to Plan 1 except three widths of bundled steel chain were placed along the toe from Profile 4 to the elbow (Figure 12). A single chain was placed at the toe at the elbow to the terminus of the quay wall. Additionally, a single chain was placed around the toe of the tetrapod section. The purpose of the chain was to stabilize the toe to observe the stability of upslope units. Rebuilding of the 8-tonne Core-Loc section resulted in $\phi = 0.60$. The addition of the chain stabilized the Core-Locs at the toe; however, wave energy also displaced the chain and it was necessary to reposition the chain between wave series. The armor layer loosened between Profiles 4 and 5, and apron material was displaced for wave conditions up to 17-sec, 5.2-m, but the section remained stable (Photo A13). During the 17-sec, 5.2-m condition, 11-tonne units at the toe near Profile 10, which was unprotected by the chain, were removed by waves, causing the upper units in this area to be displaced. A hole developed in the armor layer near the crown at Profile 10, which increased in size and migrated “north” along the structure (Photos A14 through A16). Additionally, green water overtopping was observed over the +5-m CD breakwater section for waves 3.7 m in height and greater. The severe breaking condition migrated to deeper water as peak period and/or wave height increased.

Plan 1C was the same as Plan 1B except three widths of steel chain were included along the toe from Profile 4 to the leeward side of Profile 11 for Plan 1C (Figure 12). In addition, the chain was anchored to the breakwater at approximately 8-m (prototype) intervals using pins inserted under the structure. The breakwater was rebuilt prior to experiments and the resulting packing densities for the 8- and 11-tonne Core-Locs were 0.62 and 0.59, respectively. The structure was stable for waves up to 6.7 m, but it was observed that the armor layer loosened in areas between chain anchors. During 16-sec, 6.7-m waves, one

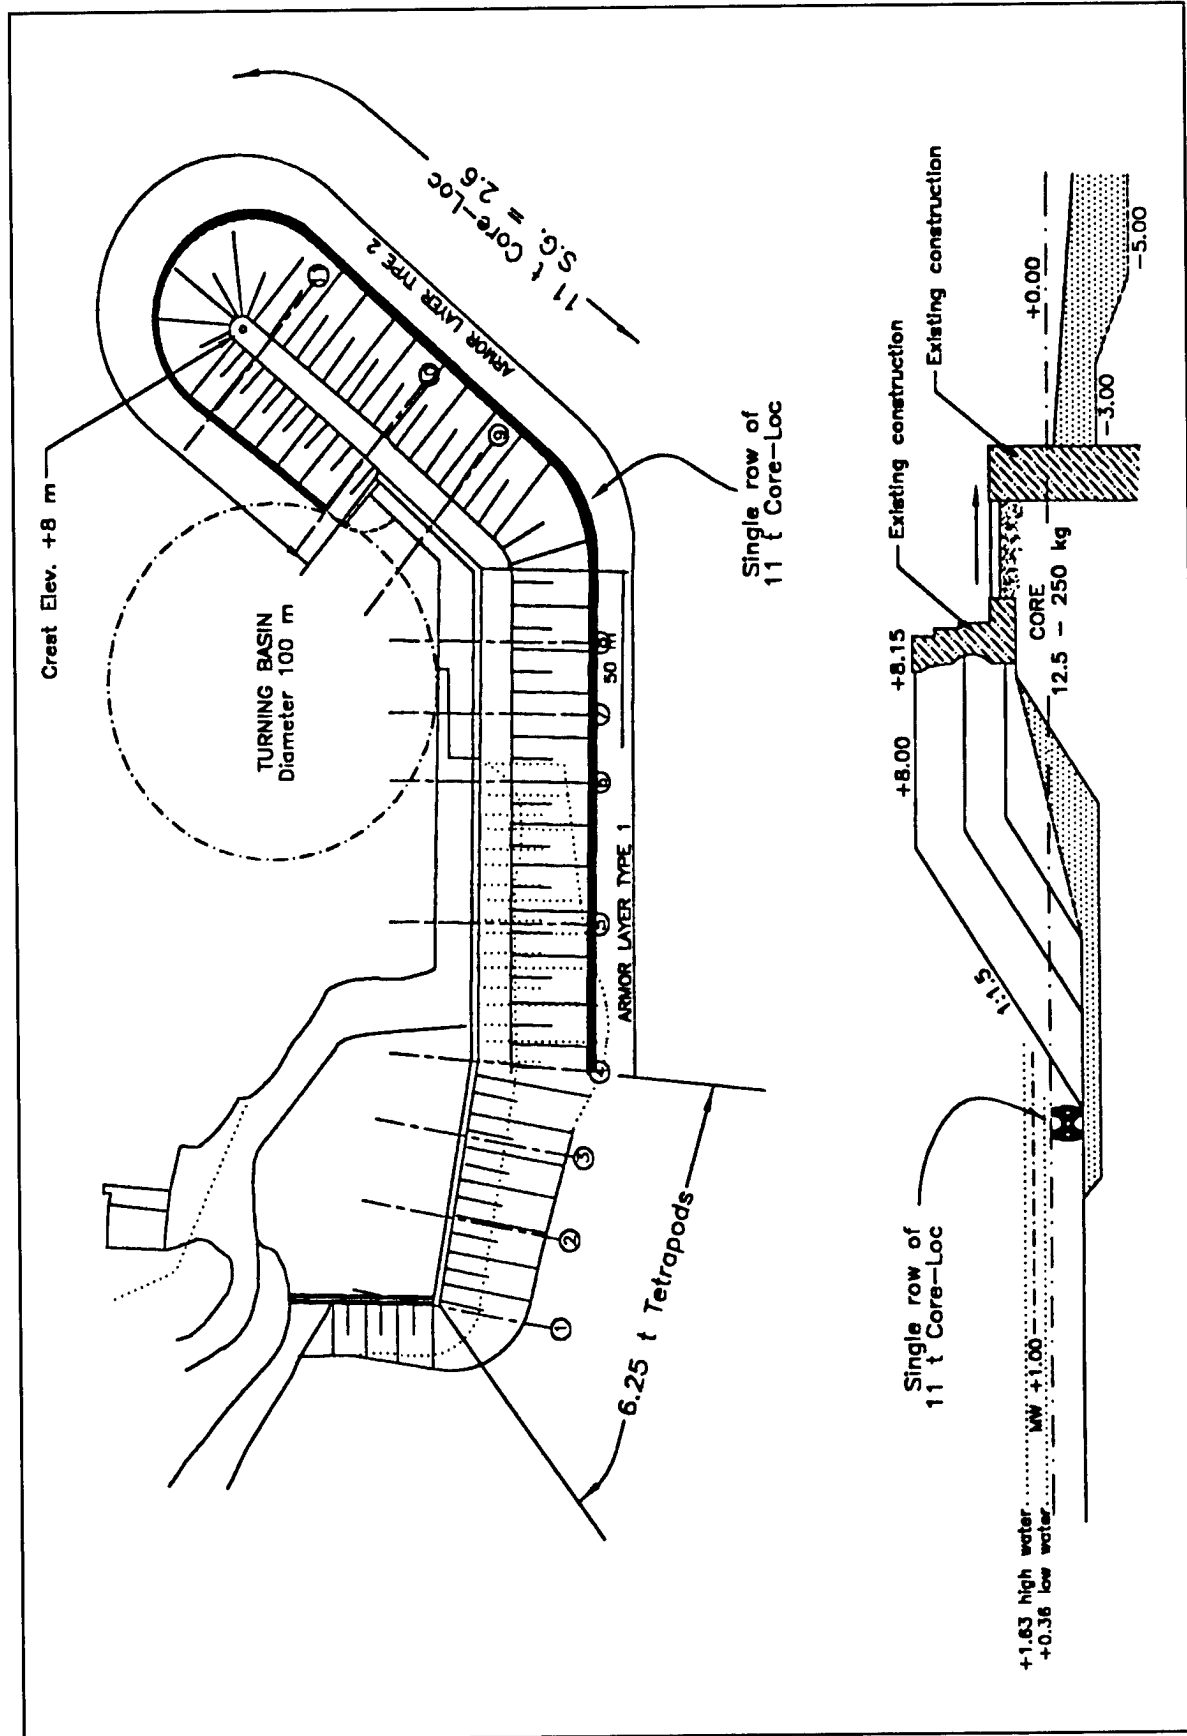
Figure 13. Elements of plan 2

Based on observations of the model and conversations with JV RRI-BCEOM personnel Messrs. A. Merrien and L. Fischer, Plan 2 consisted of raising the +5-m head portion of the breakwater to bring the entire structure to +8 m to reduce overtopping. The 8-tonne units were replaced with 11-tonne Core-Locs and the toe was reinforced with additional 11-tonne units placed in a single row (Figure 13). The packing density of the 11-tonne Core-Locs was 0.62. Toe protection units were placed 90 deg to the toe units of the structure in a manner in which adjacent units interlocked (Photos A23 through A25). The 11-tonne Core-Locs used for toe protection were displaced during 13- and 16-sec, 3.7-m waves, and the armor layer failed due to toe instability (Photos A26 and A27).

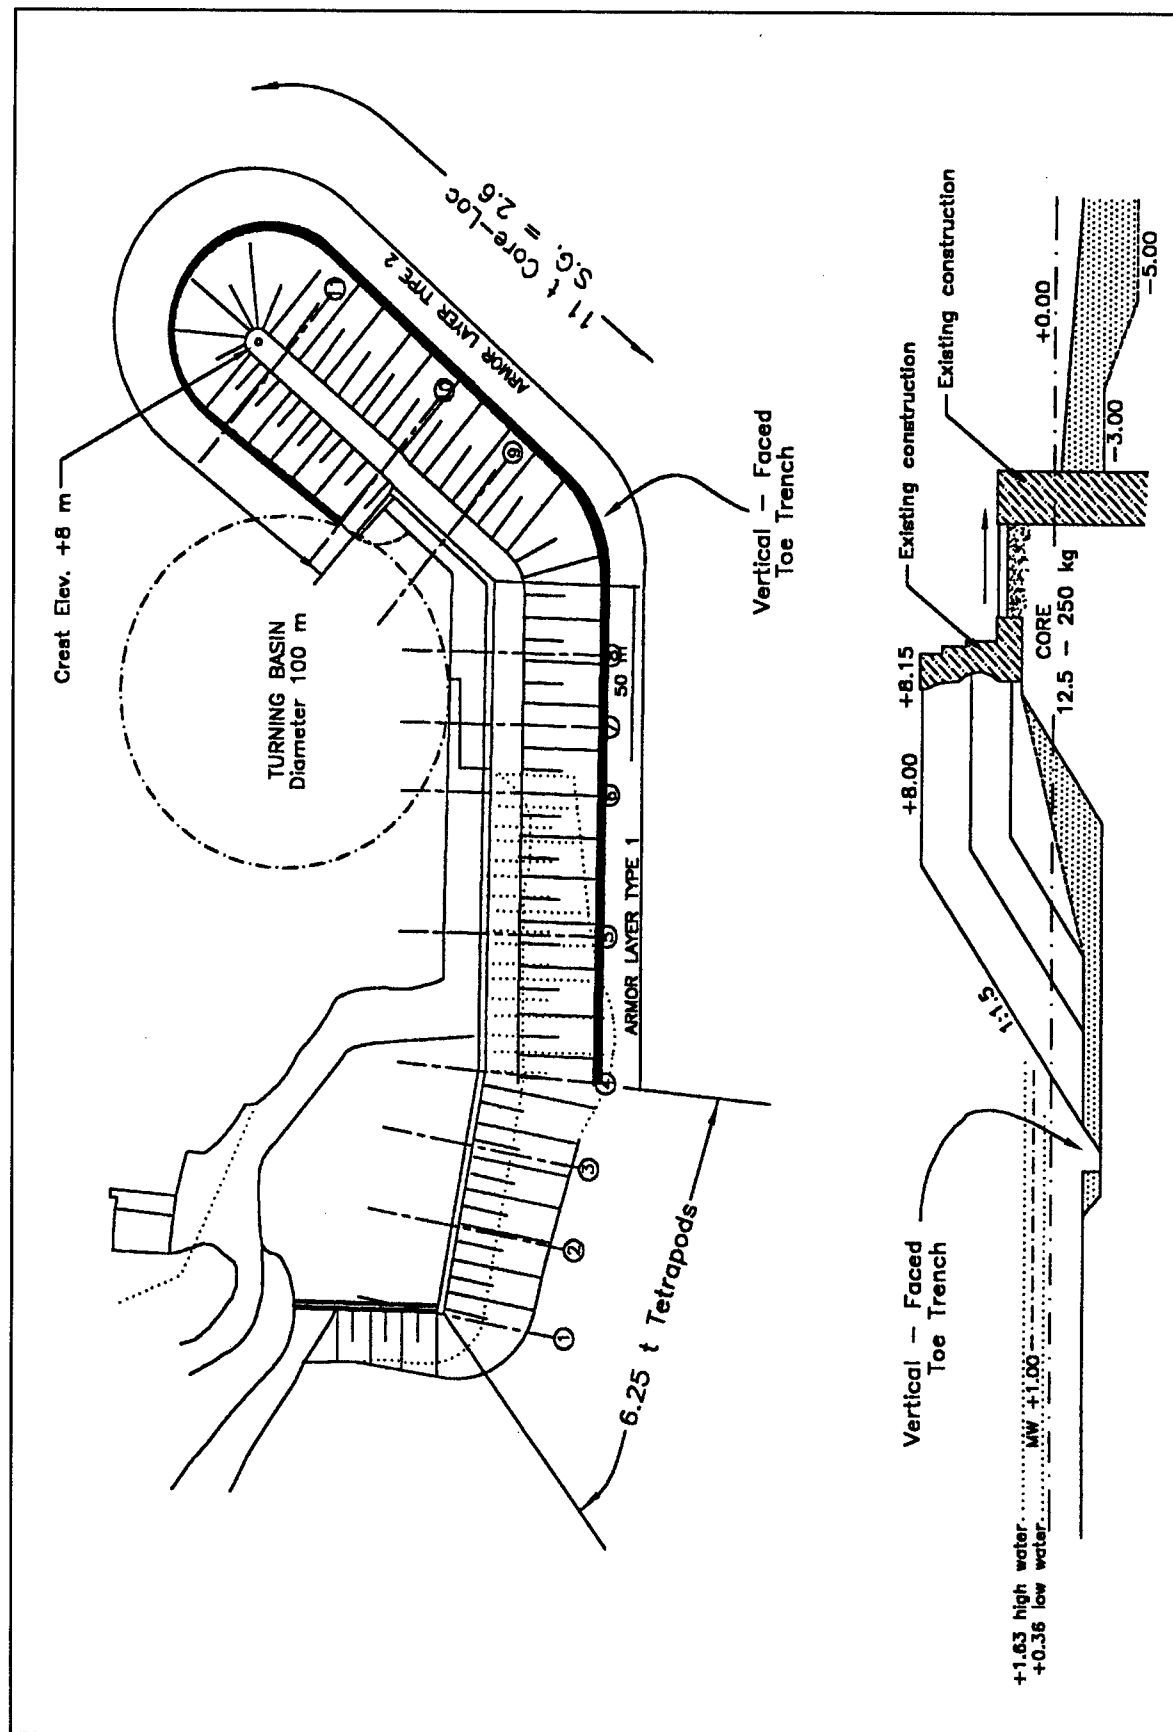
23 Figure 15. Elements of plan 2B

Plan 2B was identical to plan 2A except the toe reinforcement was constructed using a board anchored to the floor to represent a toe trench 1.5 m high with vertical sides (Figure 15). The breakwater armor was rebuilt and the packing density for the 11-tonne Core-Locs was 0.63. To expedite the study, all 3.7-m waves and the 13-sec, 5.2-m condition were omitted for this test series. From previous experiments with plans which included a restrained toe, the omitted wave conditions caused no or only minor damage to the breakwater. No units were displaced during this series (Photos A34 through A36). Plan 2B was rebuilt with the same packing density and the experiment was repeated. One Core-Loc was displaced off the head midway through 19-sec, 6.7-m waves, but the structure remained stable throughout the rest of the wave condition.

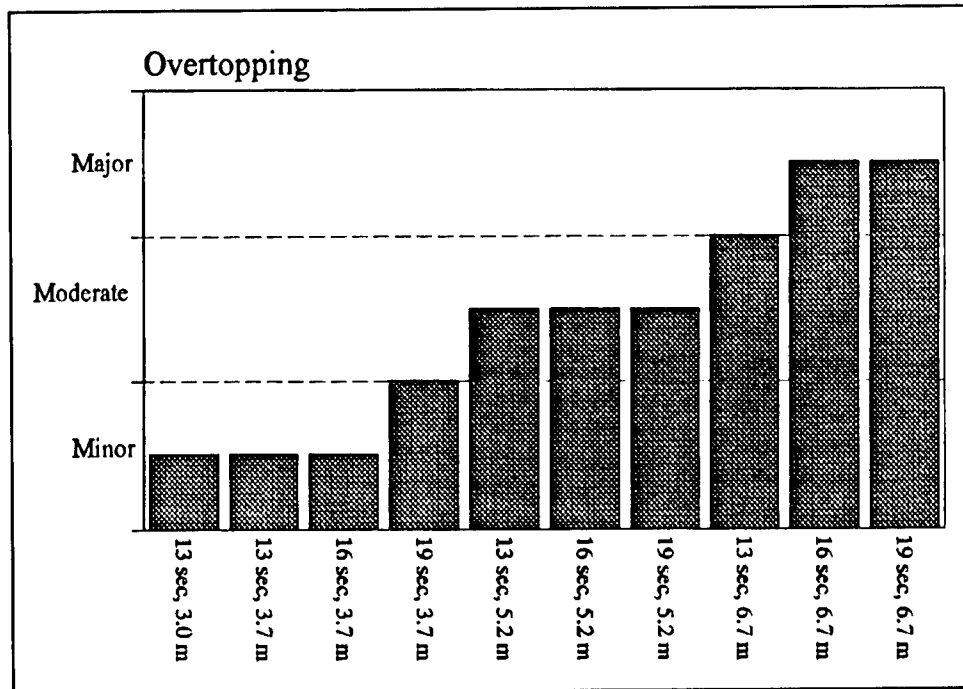
Figure 17. Wave overtopping at trunk, all plans

The classification of overtopping (minor, moderate, or major) is plotted versus wave condition in Figures 17 through 19. The wave conditions in the figures are labeled from left to right by the sequence in which they were generated during the experiment, i.e., 13-sec, 3.0-m waves were generated first and 19-sec, 6.7-m waves were generated last. Figure 17 shows the amount of overtopping that occurred at the trunk for all plans. Major overtopping occurred at the trunk for 16-sec, 6.7-m waves, but was minor or moderate for all other conditions. Figures 18 and 19 show overtopping classifications for Plan 1 and Plan 2 series experiments at the head, respectively. The figures illustrate the reduction of overtopping by raising the crest elevation to +8 m CD (Plan 2 series) from +5 m CD (Plan 1 series).

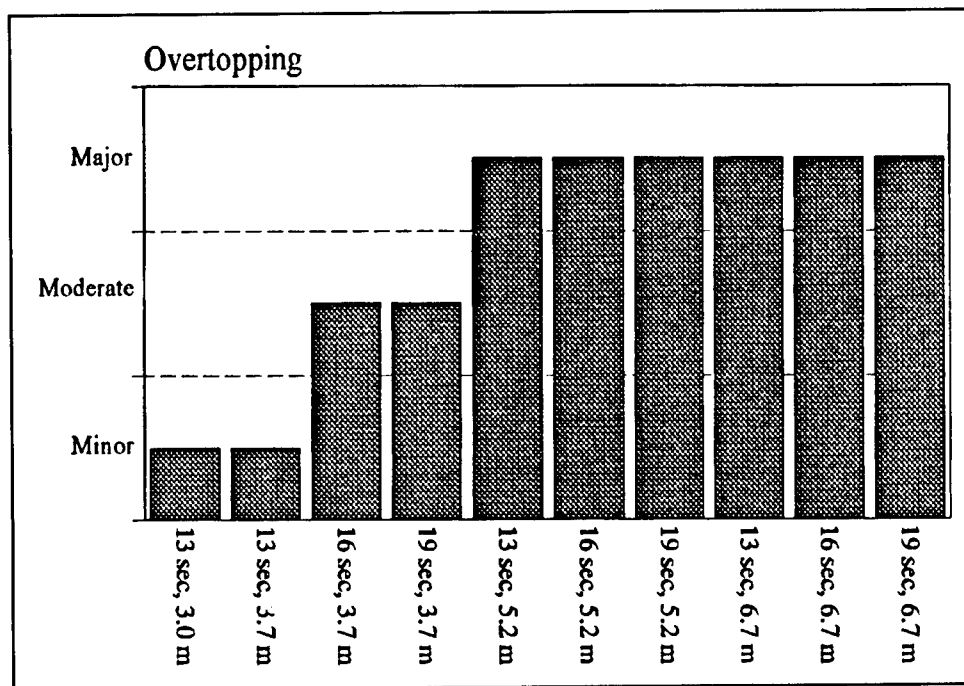
Figure 18. Wave overtopping at breakwater head, plan 1 series waves

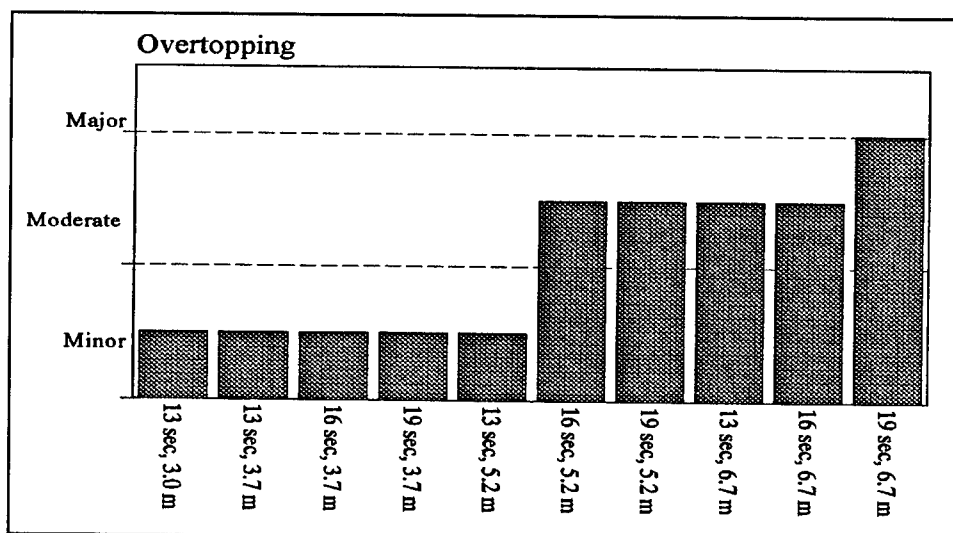
Figure 19. Wave overtopping at breakwater head, plan 2 series waves

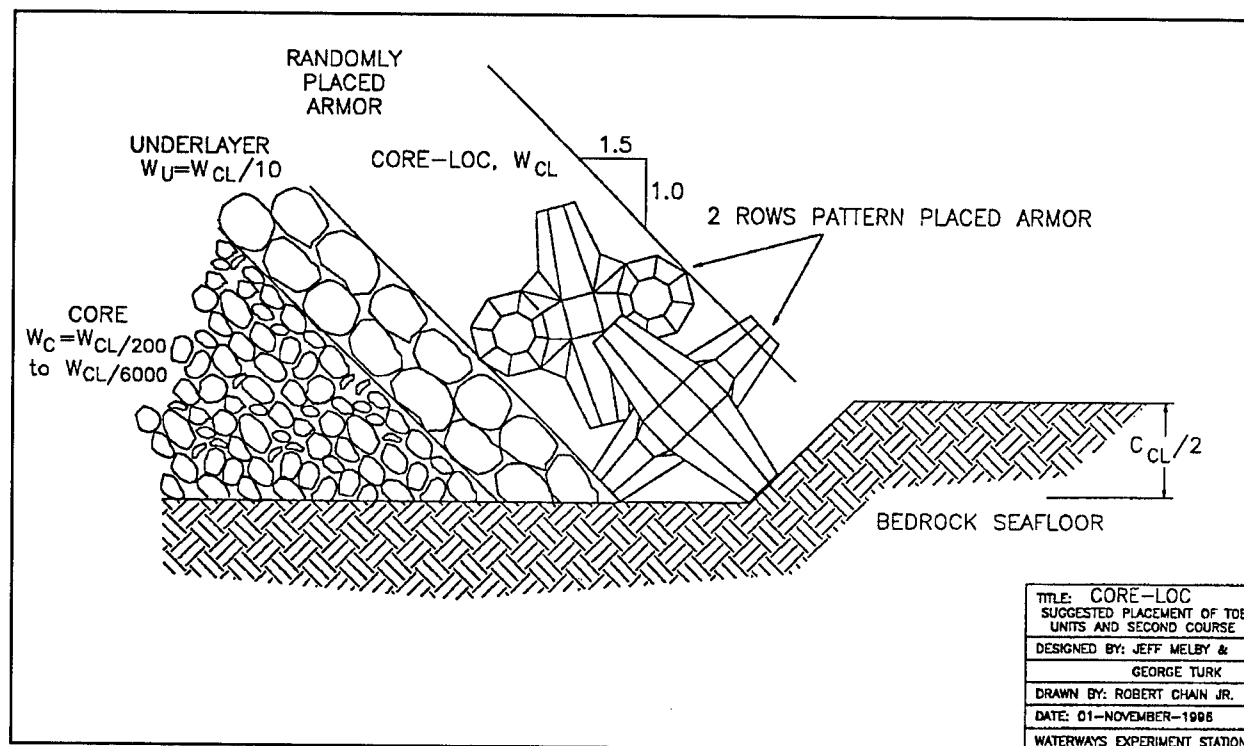
Figure 20. Example of toe trench constructed on rocky bottom

For the conditions tested in the model, the breakwater was not damaged if a stable toe trench, 1.5 m deep and near vertical, was installed. The model tests were conducted on a fixed bottom, which in nature would be analogous to a smooth rocky bottom in the prototype. An example of a prototype toe trench constructed in a rocky bottom is shown in Figure 20. The seaward face of the trench should be as near vertical as possible.

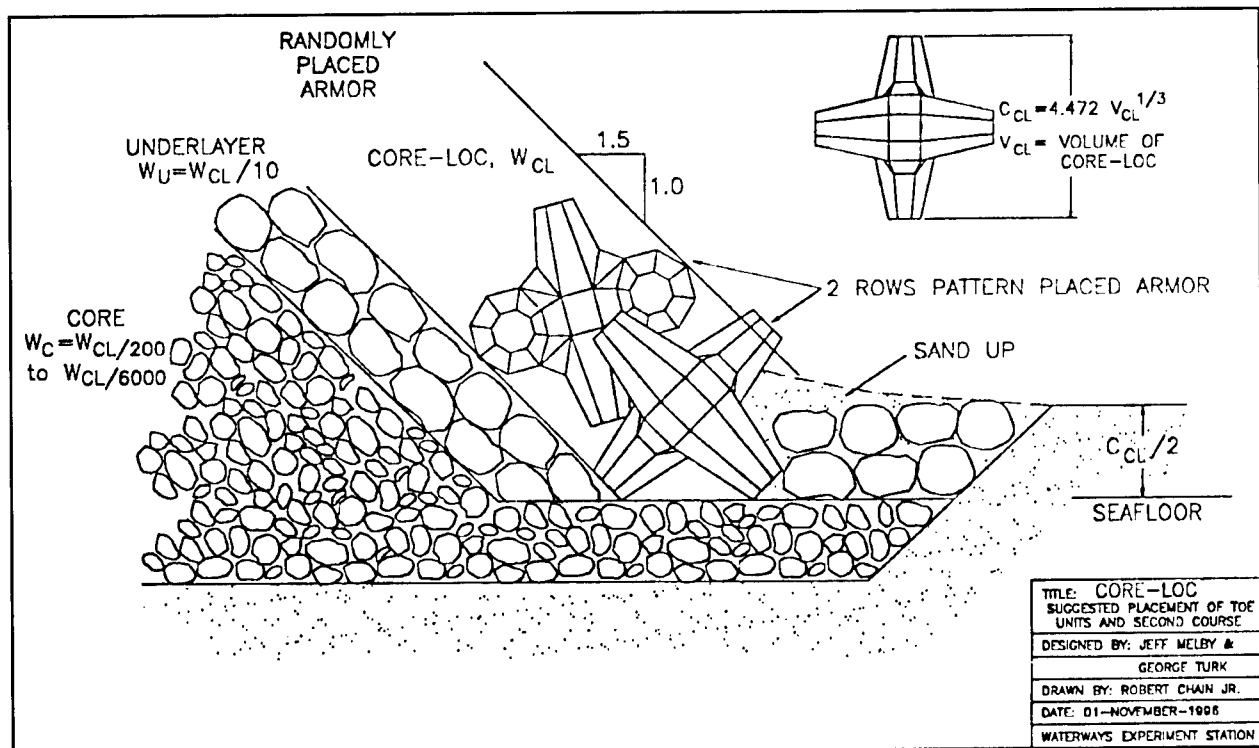
Figure 21. Example of toe trench constructed on sandy bottom

No model tests were conducted on stability with a movable bed; therefore, it was not possible to quantify the effects of a sandy bottom on the stability of the toe trench because the model floor was fixed. For structures placed in shallow water the *Shore Protection Manual* (1984) recommends a toe protection scheme similar to Figure 21, in which a wide trench is constructed and replaced with armor. The *Shore Protection Manual* suggests constructing the trench horizontally 2 times the water depth or 2 to 3 times the design wave height for the most severe scour.

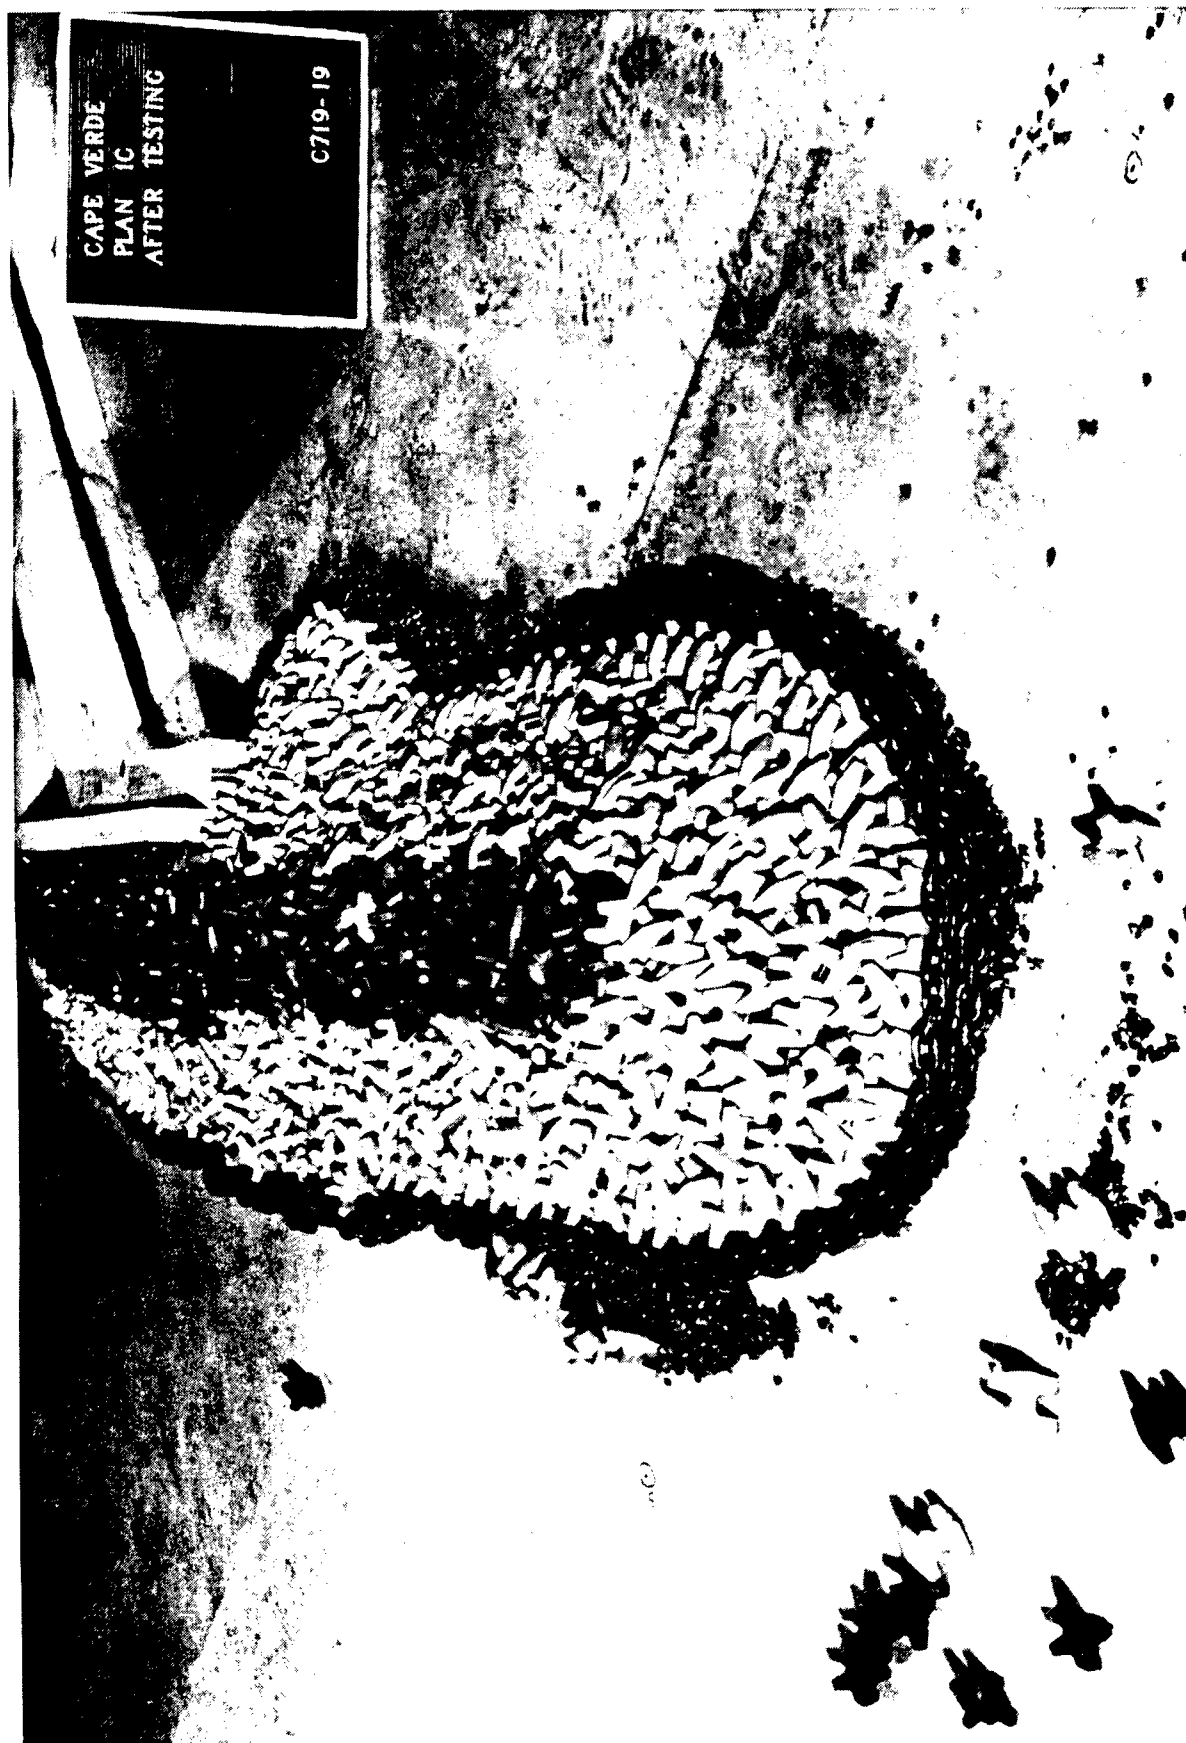
Photo A19. View of plan 1C breakwater head after testing with 19-sec, 6.7-m waves

11-tonne and three 8-tonne toe units were displaced. The toe failed near Profile 10 during 19-sec, 6.7-m waves at a location where the chain was forced seaward between anchors (Photos A17 through A19).

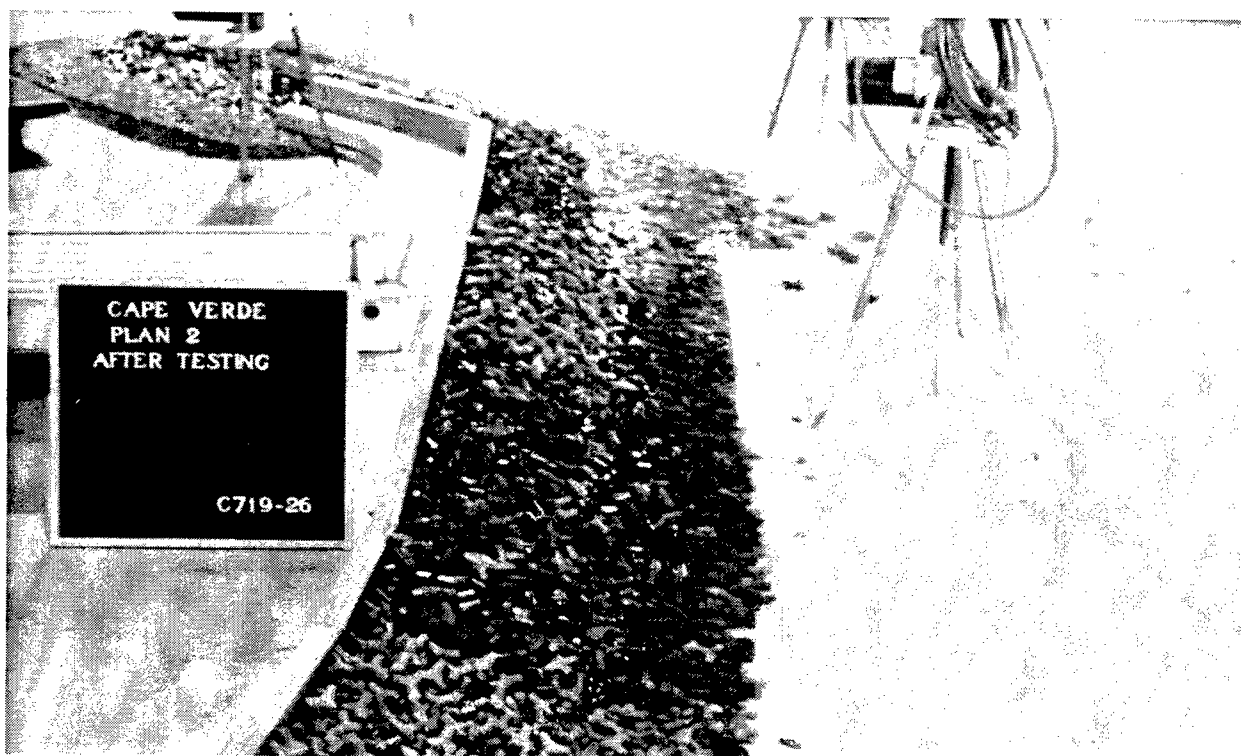
Photo A26. View from north of plan 2 breakwater trunk after testing with 13- and 16-sec, 3.7-m waves

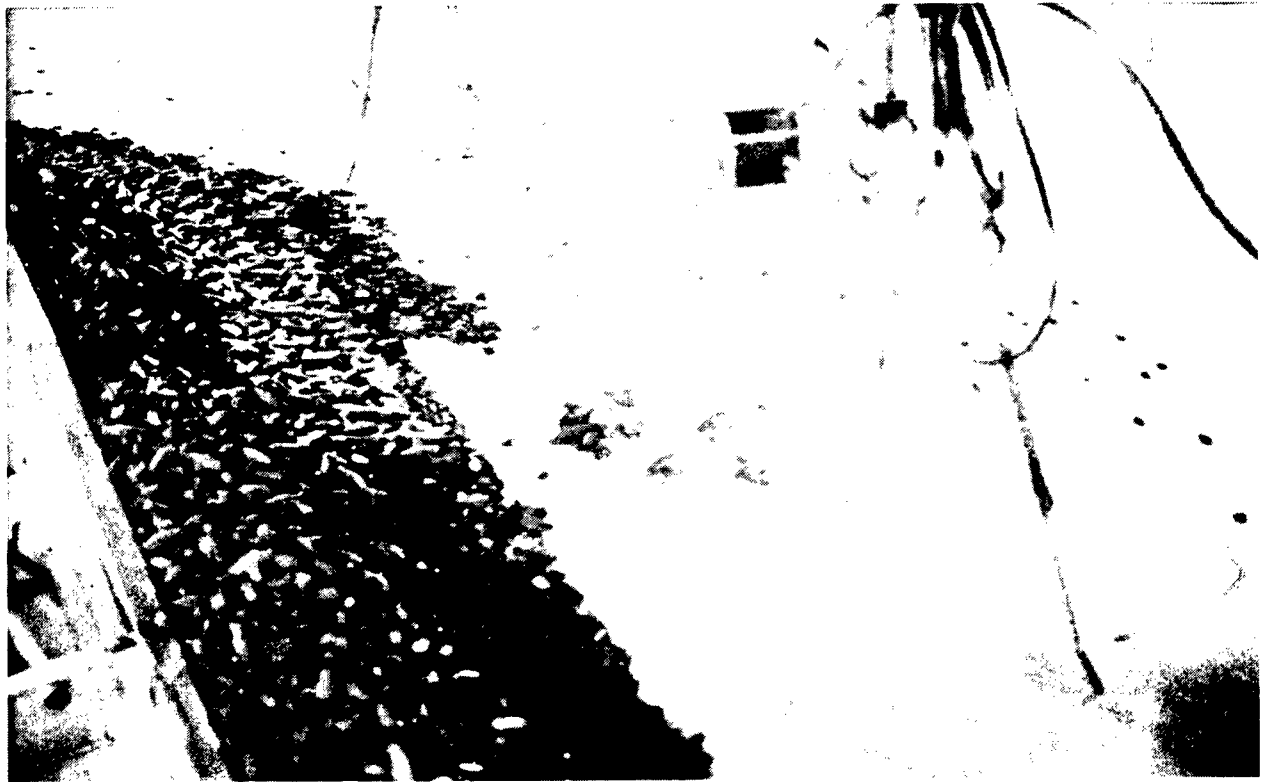
Photo A27. View of plan 2 breakwater trunk, profiles 6 to 8, after testing with 15-sec and 16-sec waves
